Subject: Boyds Bridge over Holston River Evaluation Report
Knoxville, Tennessee
Gresham Smith Project No. 48881.00

At the request of The City of Knoxville and in lieu of a full bridge inspection report, the following letter serves as an executive summary of the routine bridge inspection, as defined in the USDOT FHWA Bridge Inspector's Reference Manual (BIRM) (Publication No. FHWA NHI 12-049), of the Boyds Bridge located in Knox County, Tennessee at 4078-4226 Boyds Bridge Pike, Knoxville, TN 37914. The purpose of this letter is to provide The City of Knoxville with information on the November 7th, 2024 evaluation approach, findings, results and recommendations. The evaluation was performed by Gresham Smith using staff that meet the bridge inspector qualifications outlined in The *Code of Federal Regulations*, Title 23, Part 650, Subpart C, Section 650.309. Gresham Smith staff on site for the evaluations were Griffin Bedell, EI, NHI and Russell Childs, PE, NHI.

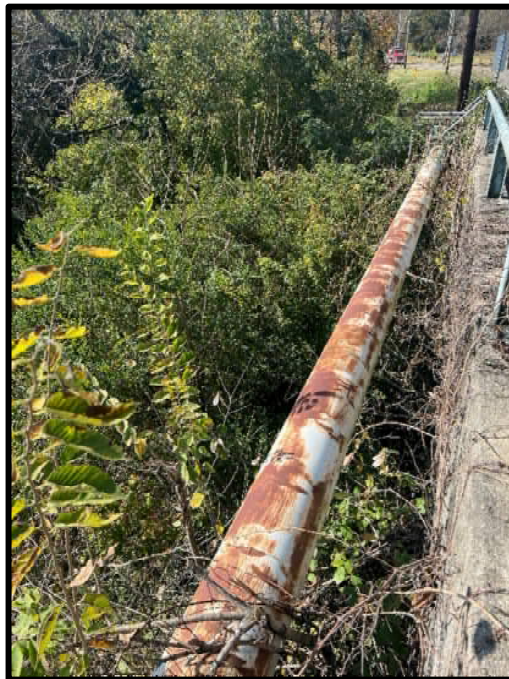
The visual aspects of the abutments are generally in fair condition with some deterioration noted where observed. Abutment No. 1 is surrounded by extreme vegetation (Photo 4). Therefore, the abutment is inaccessible to evaluate. Abutment No. 1 and No. 2 are integral abutments (Photo 5). Minor efflorescence was observed on Abutment No. 2 during the bridge evaluation (Photo 5). The utility hanger on the right side of Abutment No. 2 is detached (Photo 7). Some minor erosion at Abutment No. 2 slope was also observed (Photo 6).

Photo 4: Abutment No. 1 – Extreme Vegetation

The immediate recommendations to address the deterioration of the bridge includes but is not limited to: Vegetation removal under all approach spans, steel handrail repairs, heat straightening of the sway bracing, concrete spall repairs, expansion joint repairs, application of a thin epoxy overlay, sign placement indicating the vertical clearance at both portals, full and partial depth deck repairs, resetting the bearings at Pier No. 2 and replacement of the bridge sign at the West Portal.

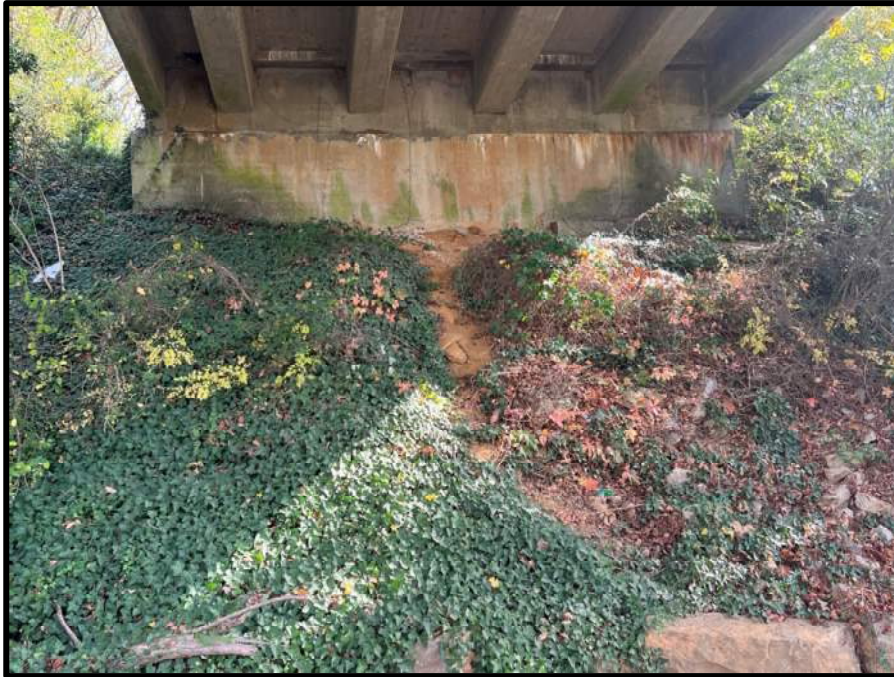
Photo 5: Abutment No. 2 (Eastern) – Vegetation and Efflorescence Observed

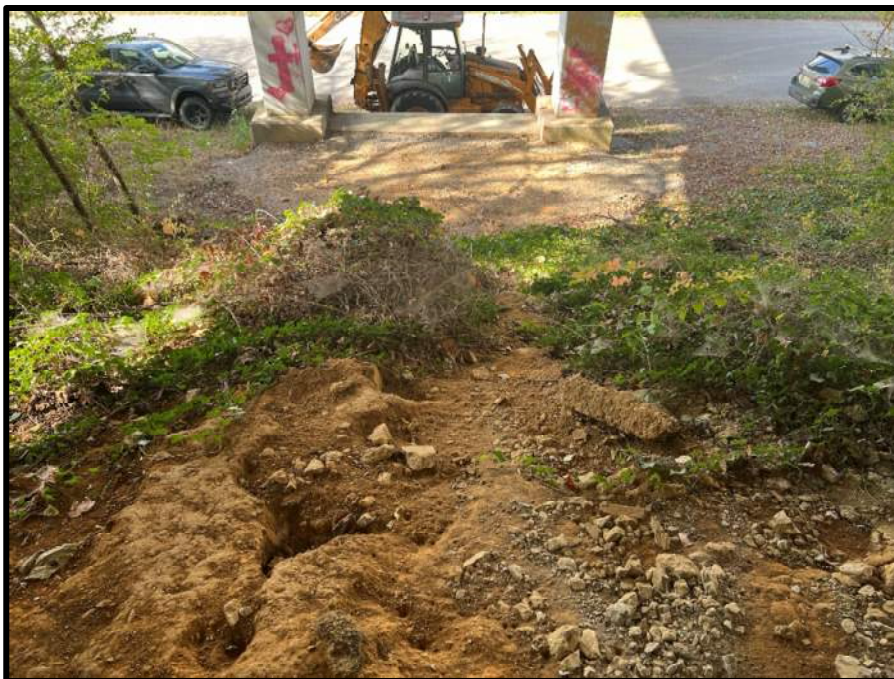
Photo 6: Abutment No. 2 (Eastern) – Slope Erosion Observed

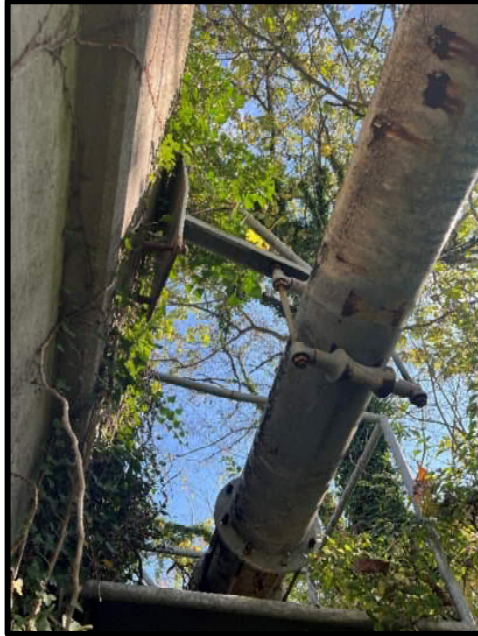
Photo 7: Abutment No. 2 – Detached Utility Hanger

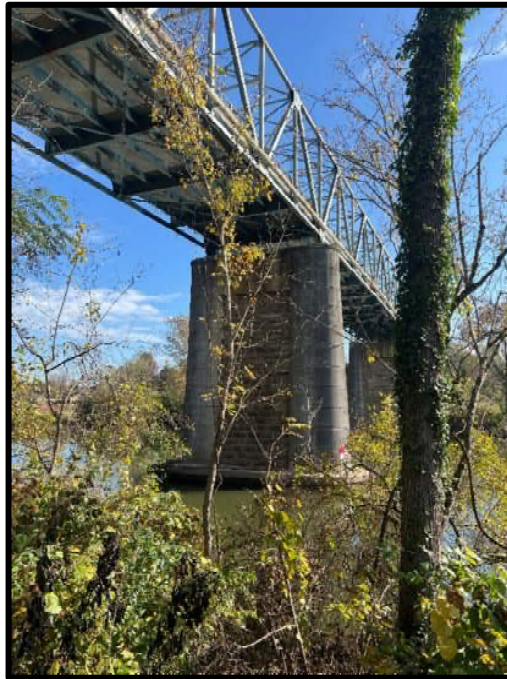
The visual aspects of the bents are generally in satisfactory condition with water staining observed (Photos 51 & 53). The visual aspects of the piers are generally in fair condition (Photo 8). The top of Pier No. 1 and Pier No. 2 footings are exposed with moderate drift build-up (Photo 9). Pier No. 2 has minor spalling and popouts (Photo 10). The bearing plates at Pier No. 1 & Pier No. 2 were inaccessible due to the visual limitation of the bridge evaluation. The bearing device at Pier No. 4 is observed to have a tilt to the East (Photo 48).

Photo 8: Pier No. 2 – General View Right Side

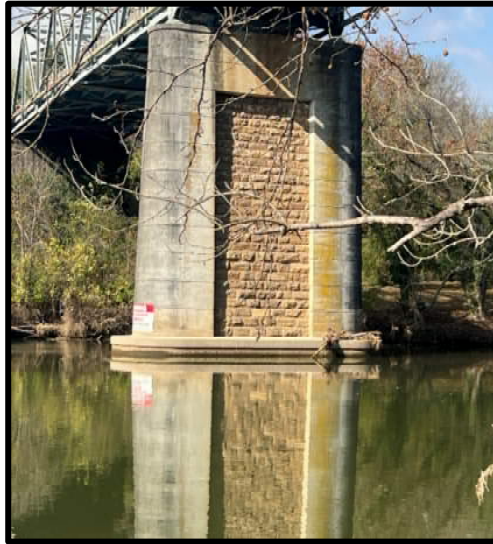
Photo 9: Pier No. 3 – Drift Build-up (typ.)

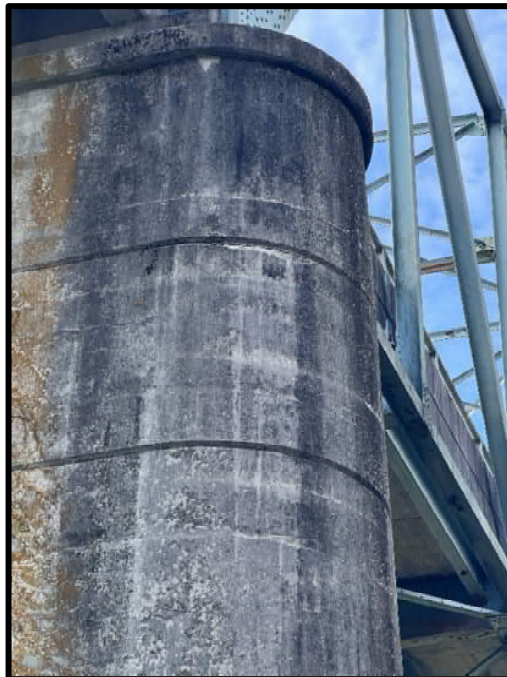
Photo 10: Pier No. 4 – Spalling and Popouts

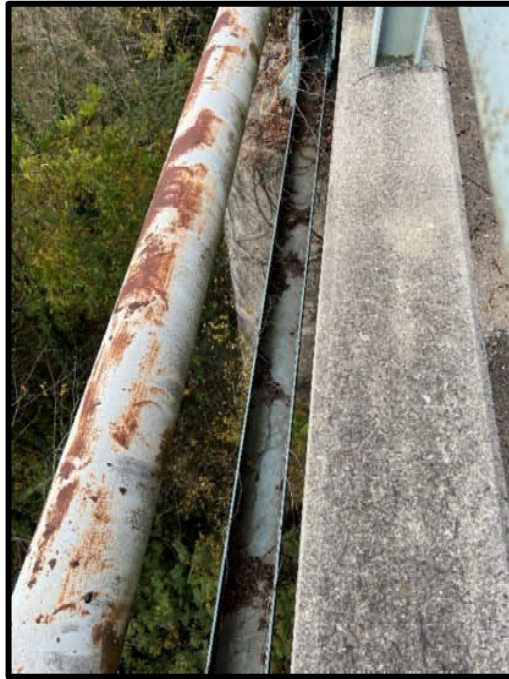
The steel truss has riveted connections at the verticals, diagonals, and the upper and lower chords (Photos 12-14). Some rivet holes are open in the beams on U13L-U14L and U15L-U16L (Photos 24 & 25). Debris/dirt build-up is noted as typical on top of the lower chord/ diagonal connections (Photos 11, 14, 31 & 32). The steel truss members are in poor condition due to the paint failure, minor section loss, and warping typical throughout the bridge (Photos 12 & 13). According to previous inspection/evaluation reports, repainting the bridge has been recommended. Truss 1 portal has collision damage and sign cracking (Photo 15 & 16). Sway frames 2, 3, 4, 6, 23, and 24 have collision damage and misalignment (Photos 17- 23 & 26-30).

Photo 11: Debris Buildup in Lower Chord L0R-L1R (typ.)

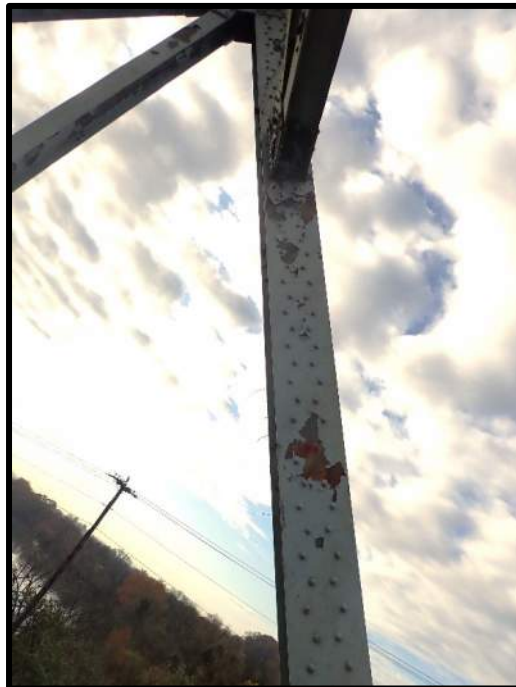
Photo 12: Truss 1, U1R-L0R Corrosion and Paint Flaking (typ. across bridge)

Future recommendations would be to clean and repaint the steel truss structure.

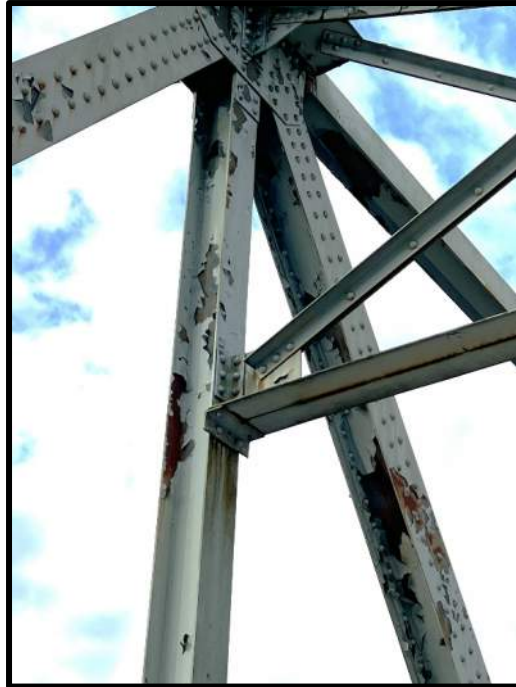
Photo 13: Truss 1, U3R-L3R Corrosion and Paint Flaking (typ. across bridge)

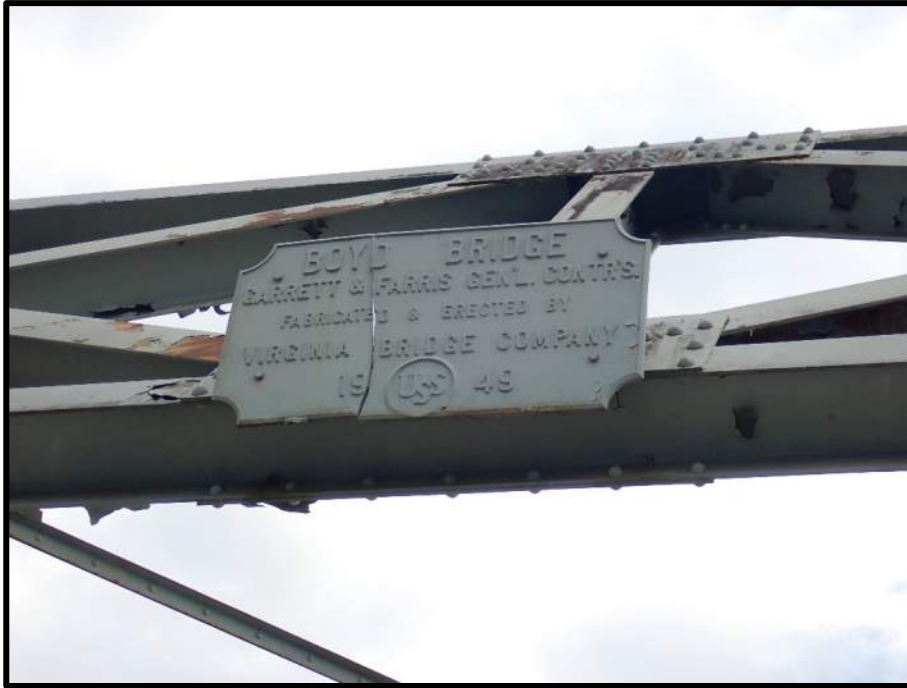
Photo 15: Truss 1, Portal - Sign Cracked Through

- (10) Item includes cost of all labor and materials to install post mounted vertical clearance warning signs at each bridge approach.
- (11) Item includes cost of all labor and materials to replace the cracked historic stamped steel sign at the West portal. No TDOT item number is applicable for this estimate.

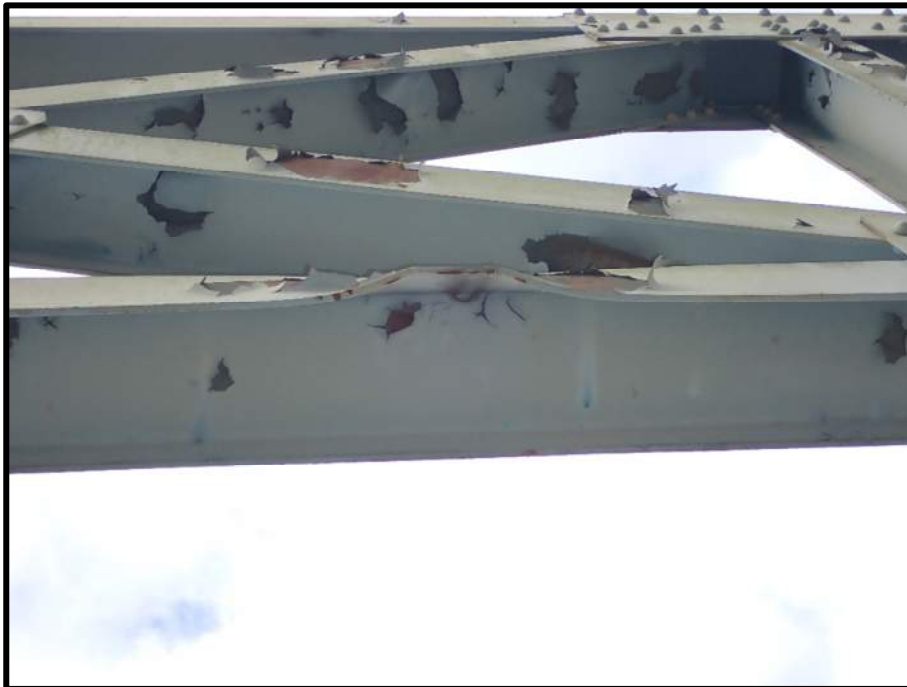
Photo 16: Truss 1, Portal – Collision Damage at Bottom Right Chord

- (4) Item No. includes cost of all labor and material to heat straighten all truss sway bracing and the West portal that is warped/deformed.
- (5) Item No. includes cost of all labor and material to perform full depth deck repairs on approx. 5% of the bridge deck (visual estimate). Actual measurements would be determined by contractor by means of chain dragging entire deck.

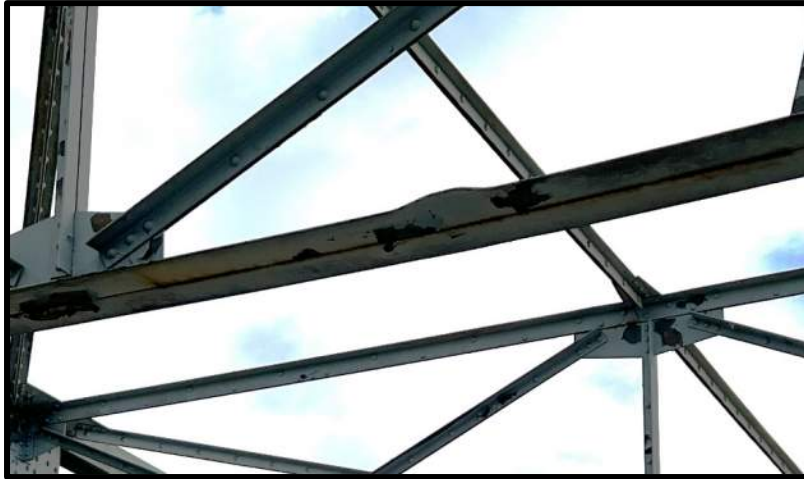
Photo 17: Sway Frame 2 – Collision Damage at Quarterspan of Bottom Right Chord

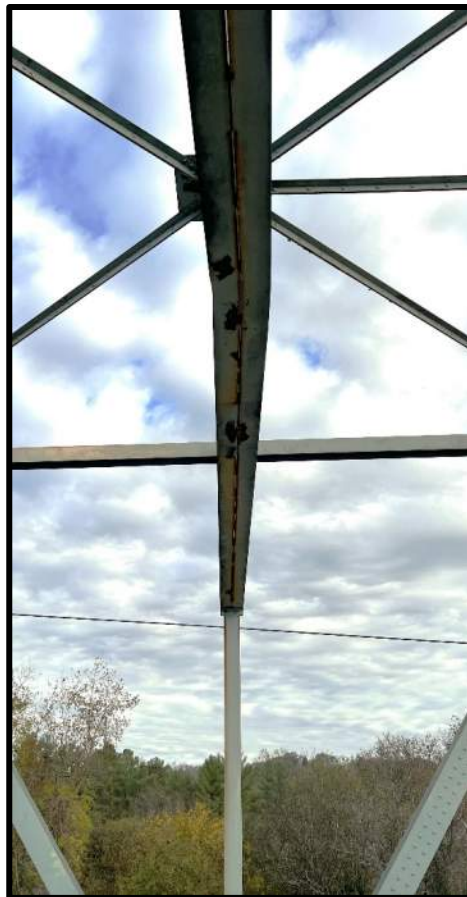
Photo 18: Sway Frame 2 - Misalignment

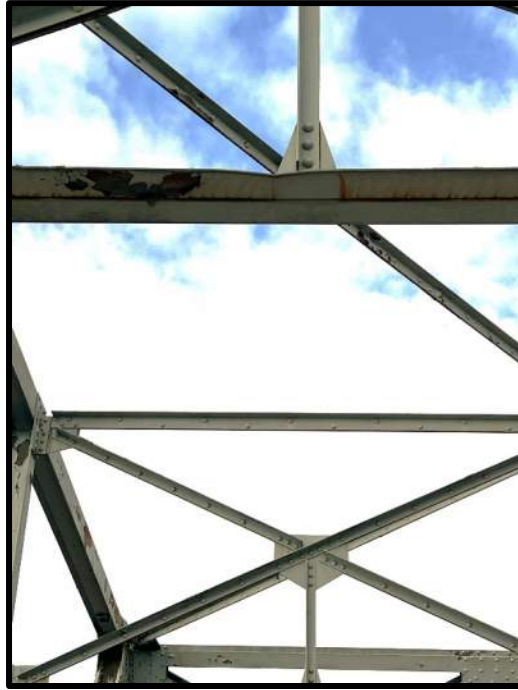
Photo 19: Sway Frame 3 – Collision Damage near Midspan of Bottom Right Chord

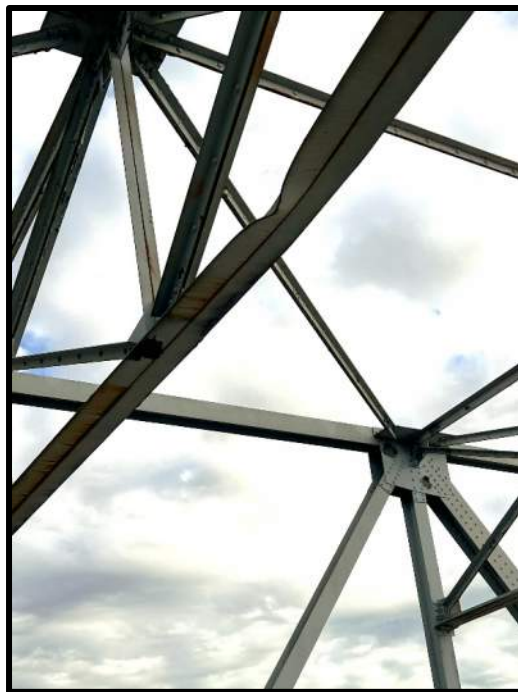
Photo 20: Sway Frame 4 – Collision Damage near Quarterspan of Bottom Right Chord

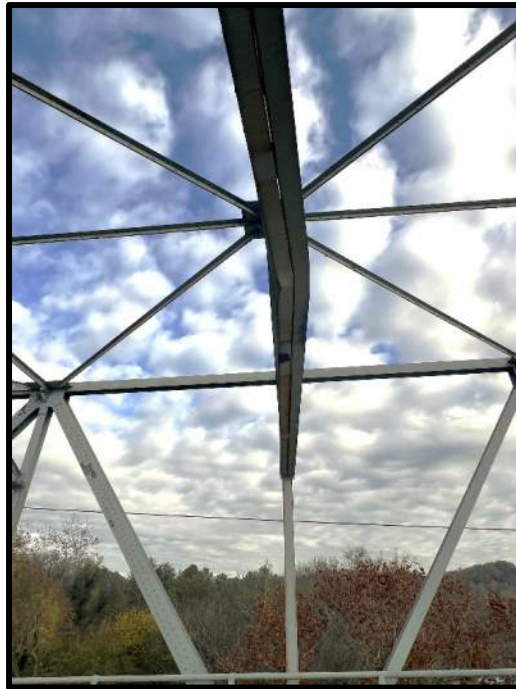
Photo 21: Sway Frame 4 – Misalignment

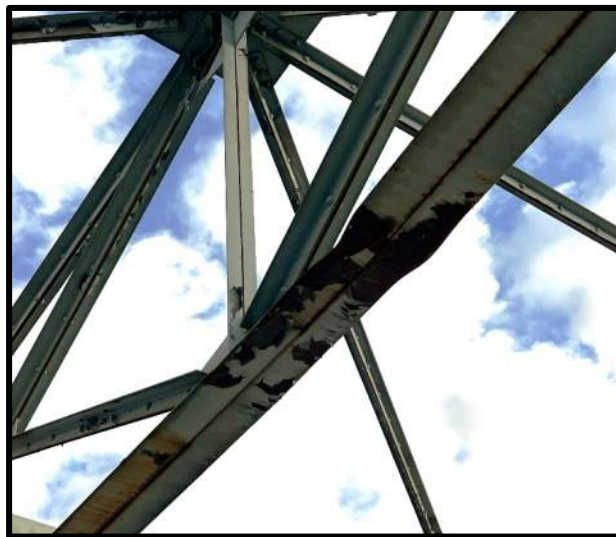
Photo 22: Sway Frame 6 – Collision Damage near Middle Web on Bottom Right Chord

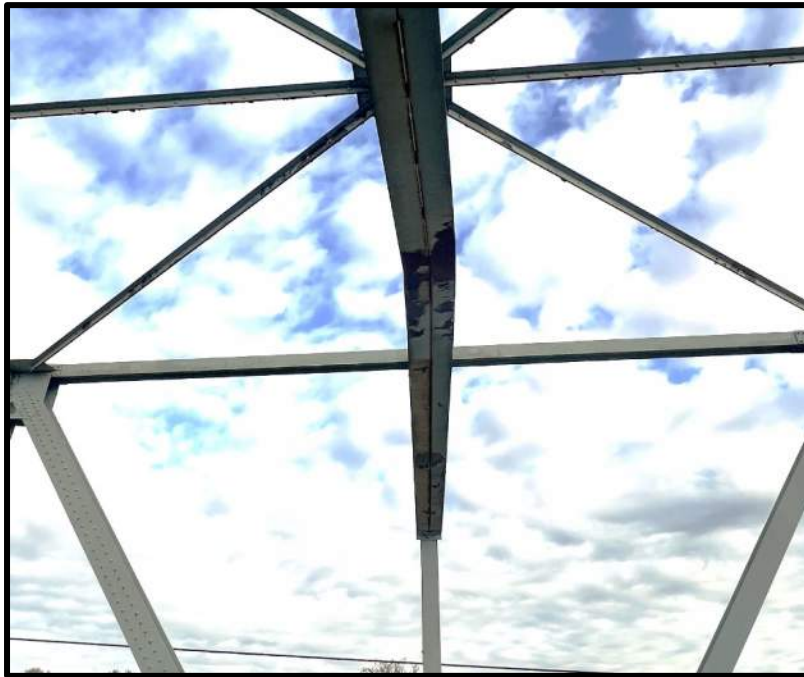
Photo 23: Sway Frame 6 – Misalignment

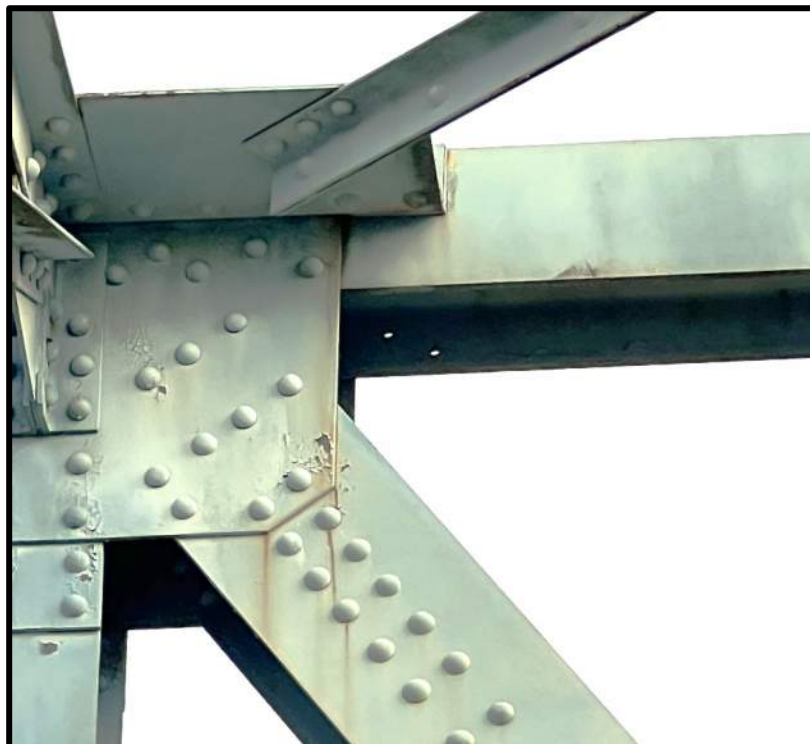
Photo 24: Truss 2, Left – U13L Missing Rivets

- (2) Item No. includes cost of all labor and material to jack the steel truss and reset the two (2) bearings at Pier No. 4
- (3) Item No. includes cost of all labor and material to replace 5 missing/ deteriorated rivets and nut assembly connection on Truss.

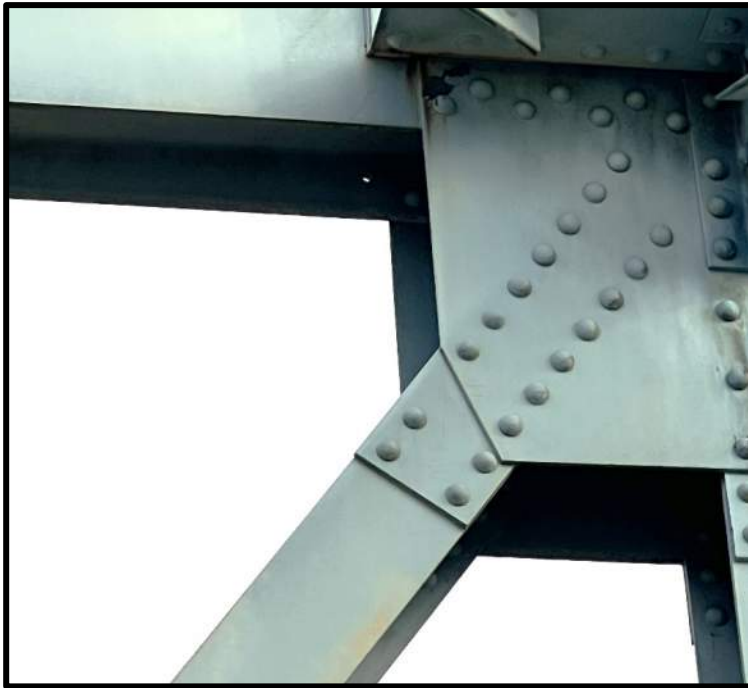
Photo 25: Truss 2, Left – U15L Missing Rivet

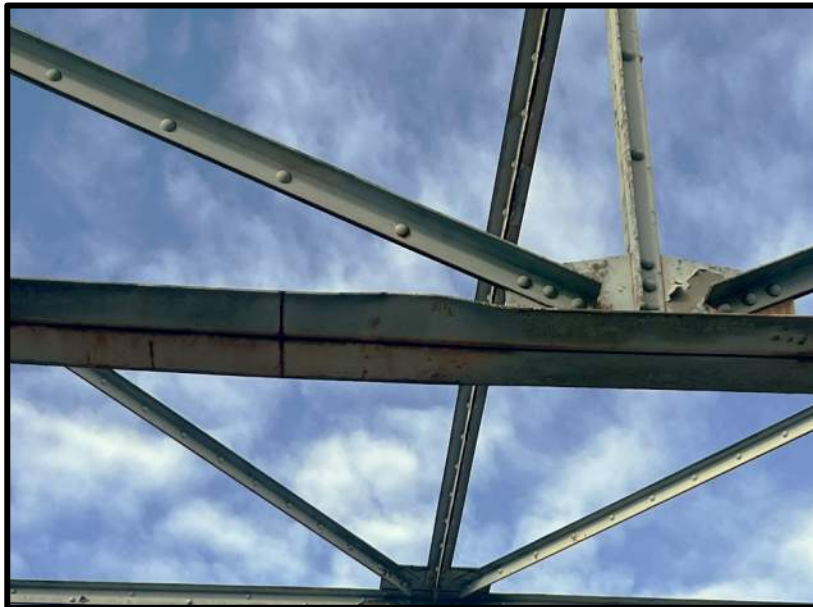
Photo 26: Sway Frame 23 – Collision Damage near Middle Web on Bottom Right Chord

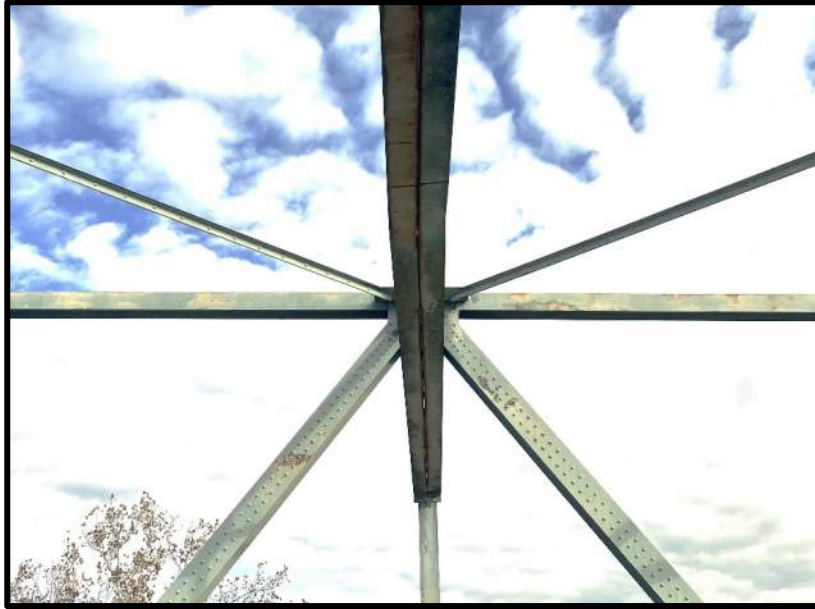
Photo 27: Sway Frame 23 – Misalignment

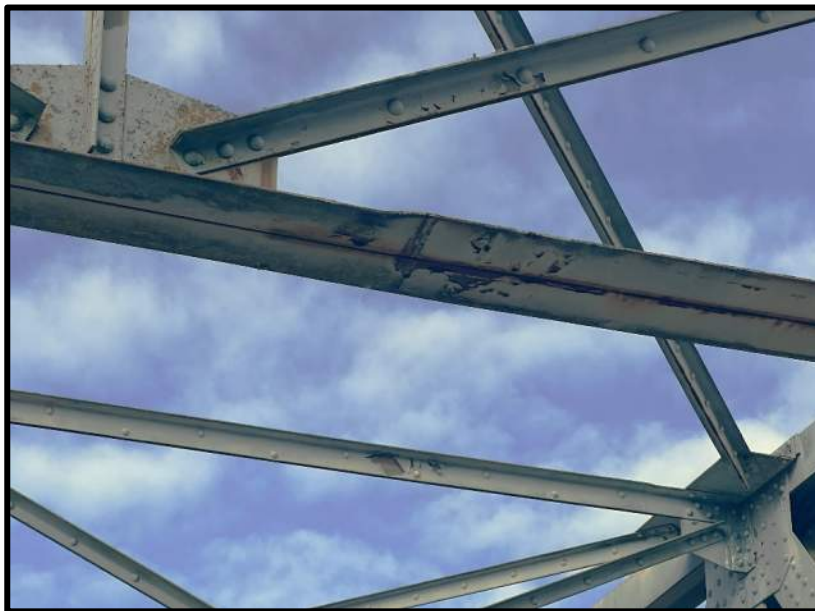
Photo 28: Sway Frame 24 – Collision Damage near Middle Web on Bottom Left Chord

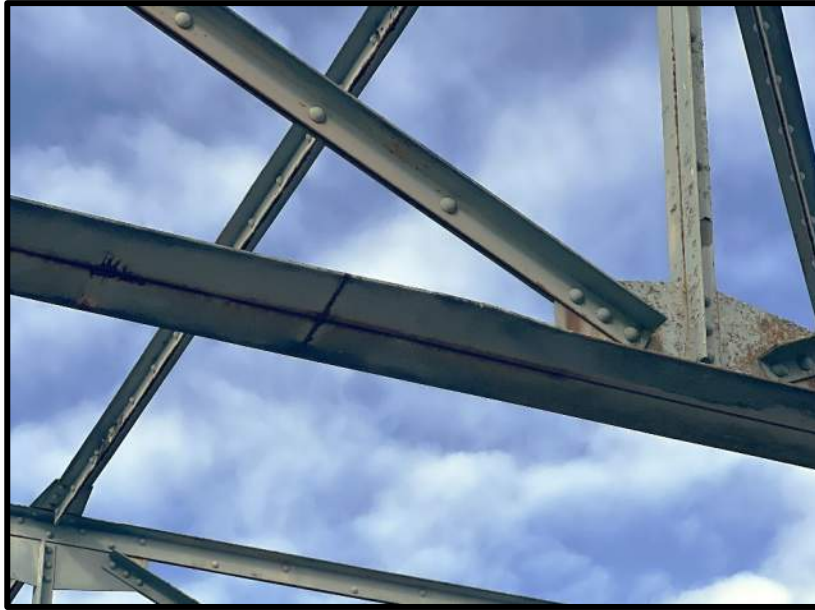
Photo 29: Sway Frame 24 – Collision Damage near Middle Web on Bottom Right Chord

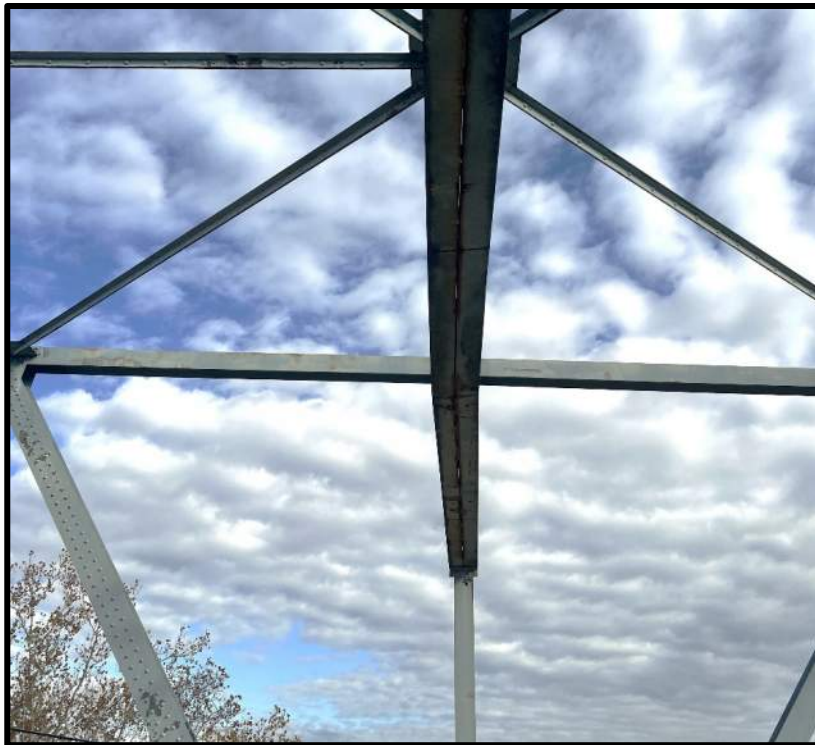
Photo 30: Sway Frame 24 – Misalignment

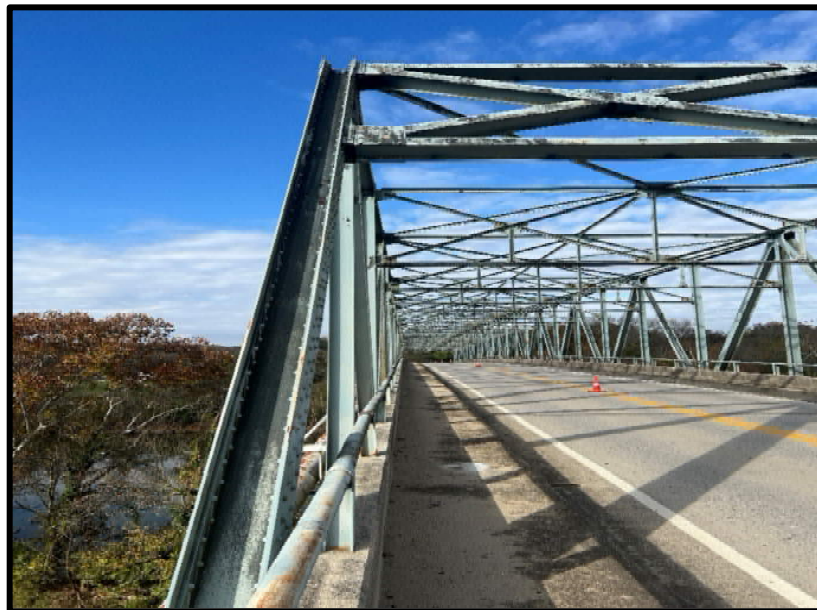
Photo 32: Truss 3, Portal – Dirt Buildup in U25R-L26R

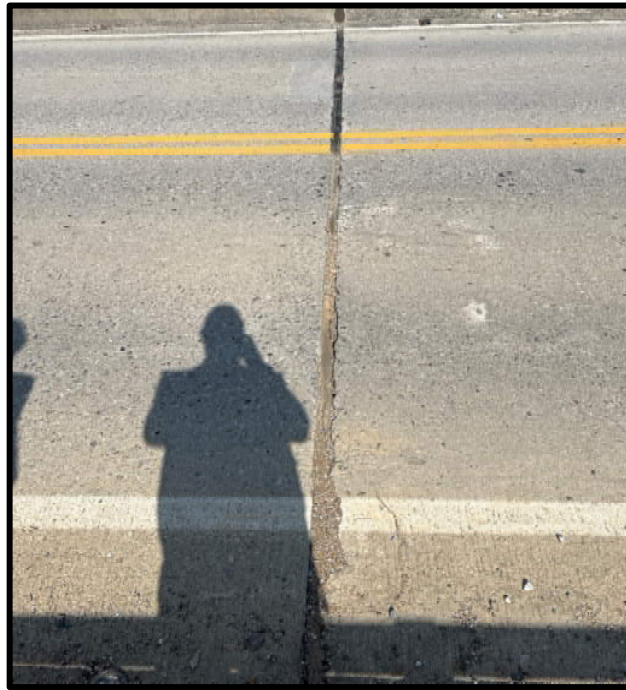
The top of the deck is in generally fair condition with typical abrasion and cracking across the entire bridge (Photo 34). The joints have typical debris buildup and the membrane of the joint at Bent No. 2 is ripped (Photo 33). The railing above L24R-L25R is observed with corrosion, cracking, and misalignment (Photo 35). The sidewalk was observed to have typical spalling and exposed rebar (Photo 36). A section of the deck at Span No. 8 above Bent No. 7 was observed to have exposed rebar (Photo 37). A section of the railing at Span No. 9 above Bent No. 8 was observed to have exposed rebar. The bottom of the deck is showing signs of moderate deterioration typical across the entire bridge. There is presence of spalling, exposed rebar, efflorescence, cracking, and failed patches (Photos 39-47 & 49-57).

Photo 33: Joint at Bent 2 – Debris Build-up (typ. all joints) and Ripping

- (6) Item No. includes cost of all labor and material to replace the joint membrane at Bent No. 2. Item number unit price was not used for this estimate.

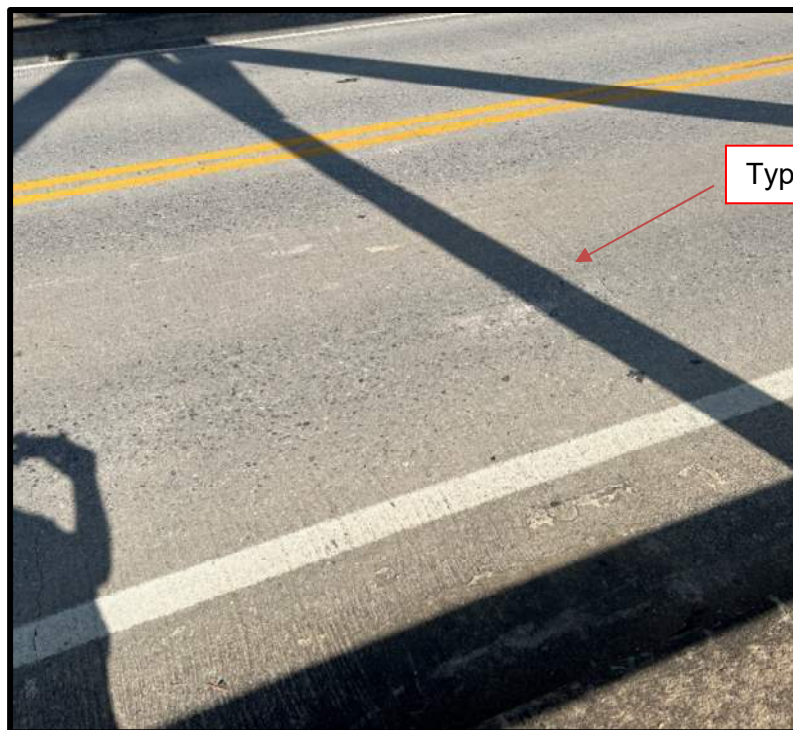
Photo 34: Top Deck – Abrasion and Cracking (typ. across bridge)

- (9) Item includes cost of all labor and materials to clean the existing bridge deck, prepare the surface for the application of the Type 1 Thin epoxy overlay, and apply the thin epoxy overlay for the entire bridge width and length using a TDOT QPL epoxy product.

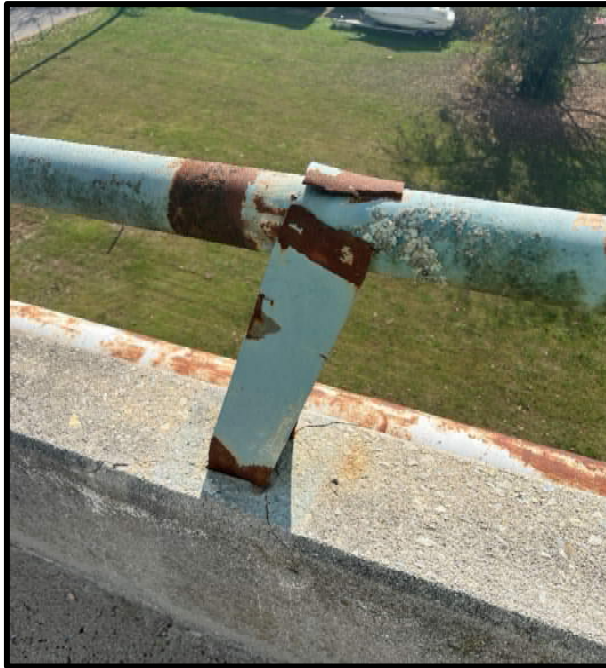
Photo 35: Railing above L24R-L25R – Corrosion, Cracking and Misalignment

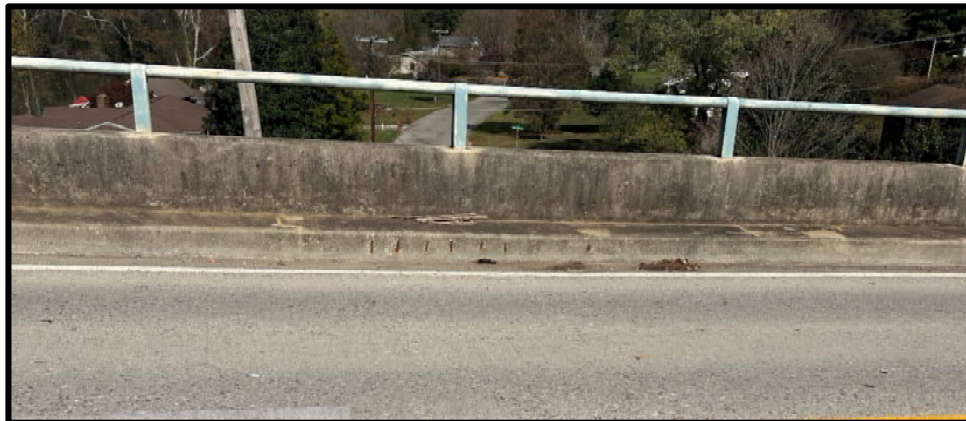
Photo 36: Span 8, Sidewalk – Exposed Rebar and Spalling Left Shoulder

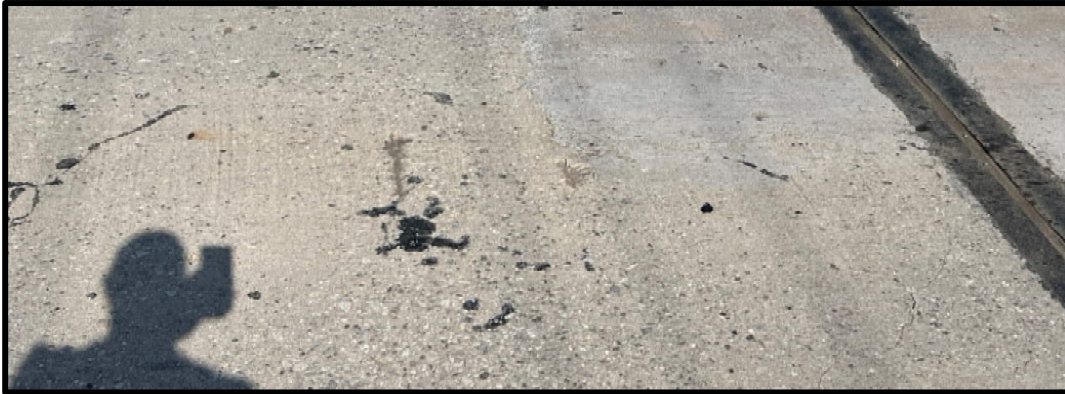
Photo 37: Span 8 above Bent 6, Top Deck – Exposed Rebar

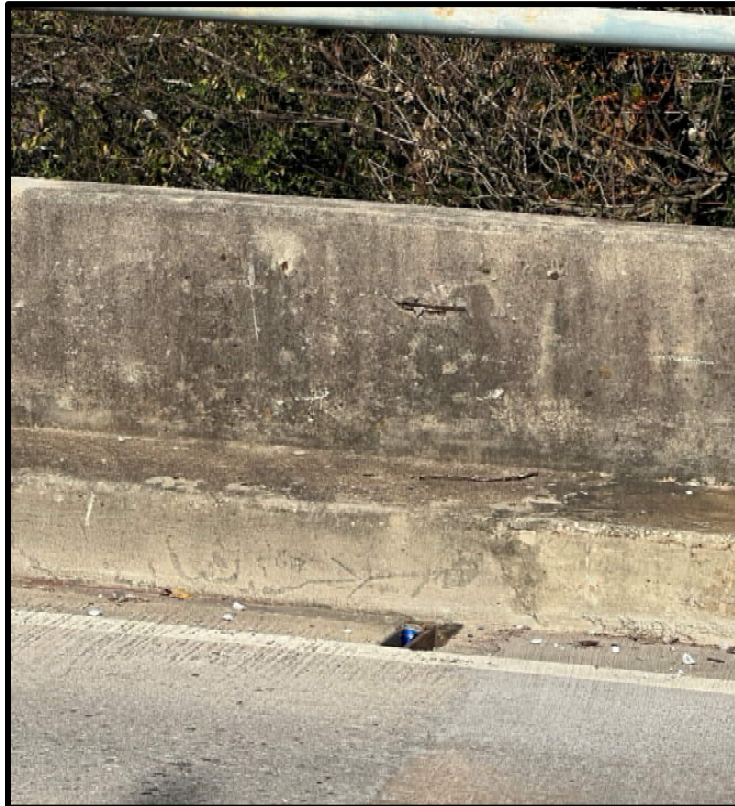
Photo 38: Span 9 at Bent 7, Sidewalk – Exposed Rebar

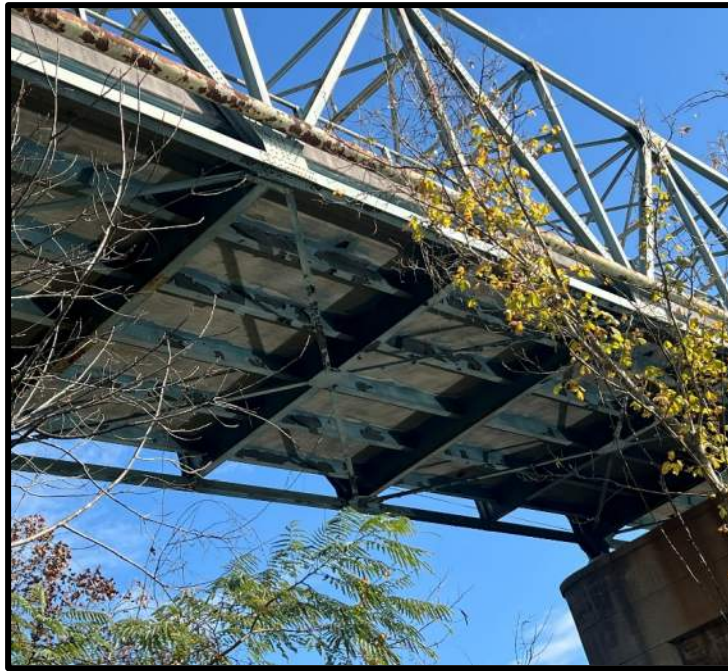
The floor beams are displaying moderate corrosion and paint failure typical across the bottom laterals of the truss (Photos 39-42). The stringers are displaying moderate corrosion and paint failure typical across the bottom laterals of the truss (Photos 39-42 & 44).

Photo 39: Truss 1, Bottom Deck Section 1-8 – General Overview and Corrosion, Spalling, Paint Peeling

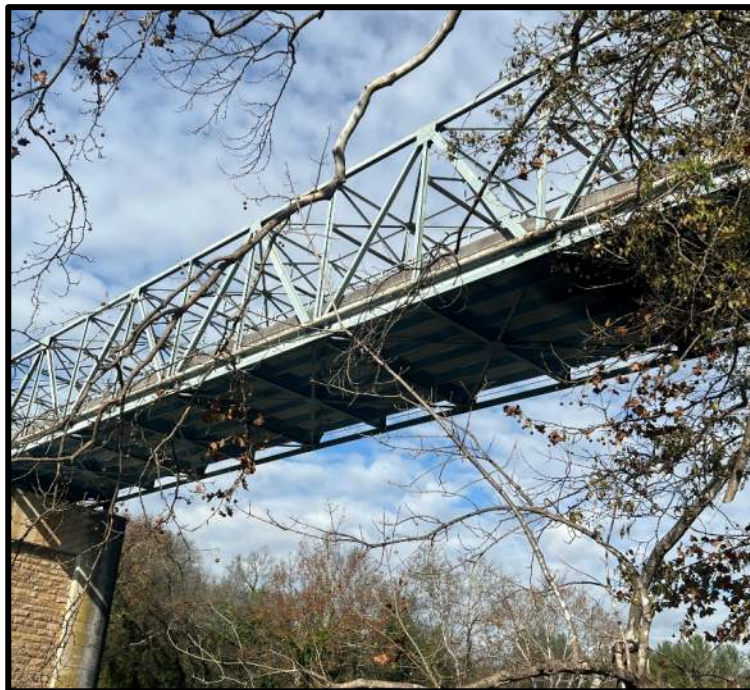
Photo 40: Truss 2, Bottom Deck Section 9-18 – General Overview and Corrosion, Spalling, Exposed Rebar, Paint Peeling

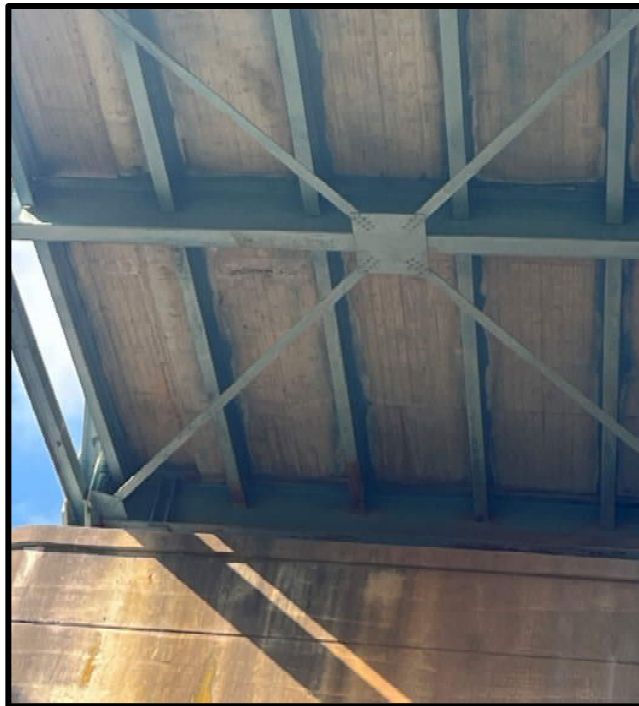
Photo 42: Truss 3, Bottom Deck Section 19 – Exposed Rebar, Spalling, Corrosion, and Paint Peeling

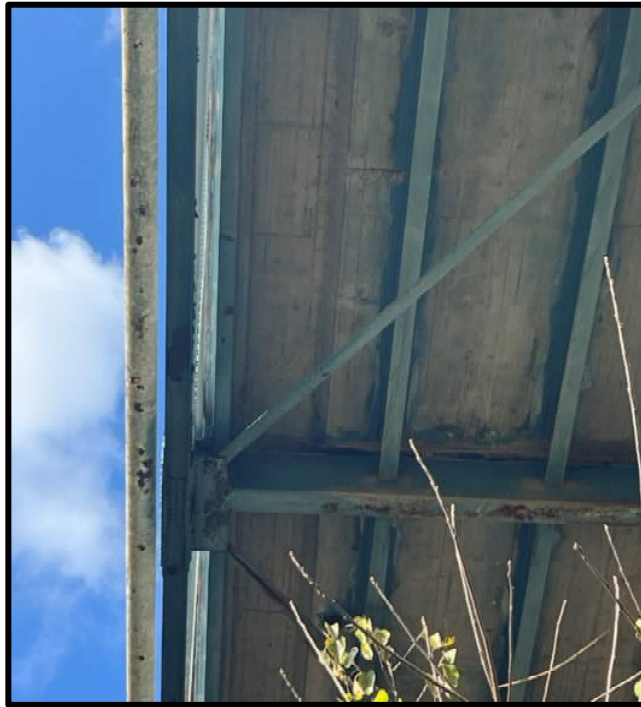
Photo 43: Truss 3, Bottom Deck Section 21 – Exposed Rebar, Spalling, Corrosion, and Paint Peeling

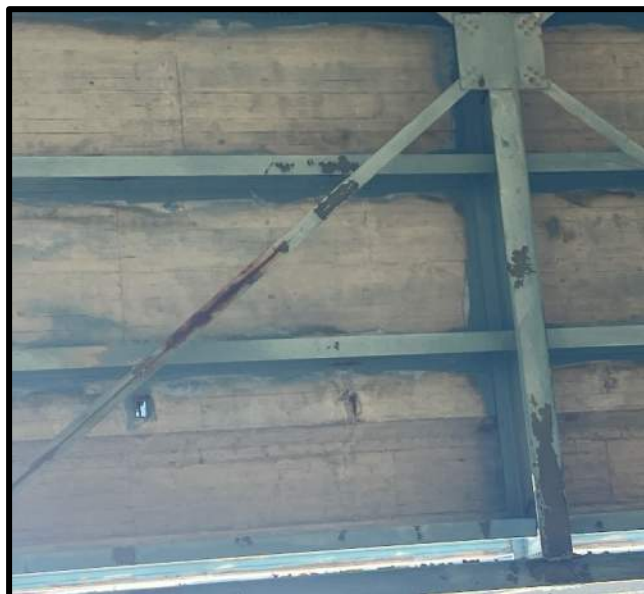
Photo 44: Truss 3, Bottom Deck Section 22 – Exposed Rebar, Spalling, Corrosion, and Paint Peeling

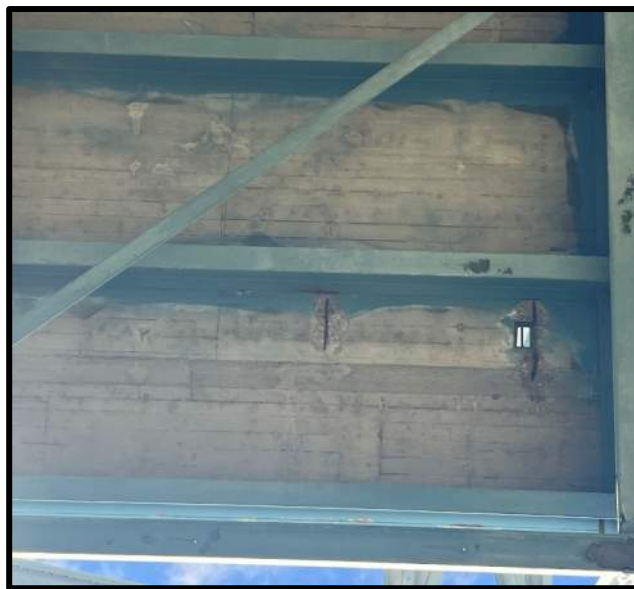
Photo 46: Truss 3, Bottom Deck Section 24 – Exposed Rebar, Spalling, Paint Peeling

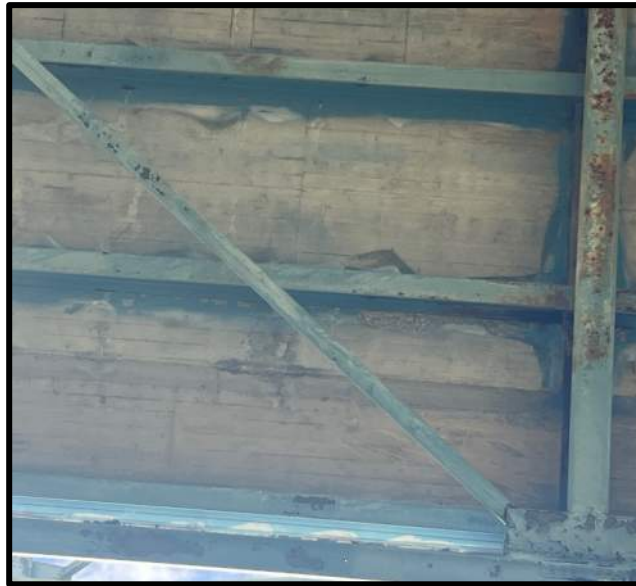
Photo 47: Truss 3, Bottom Deck Section 25 – Exposed Rebar, Spalling, Corrosion, Paint Peeling

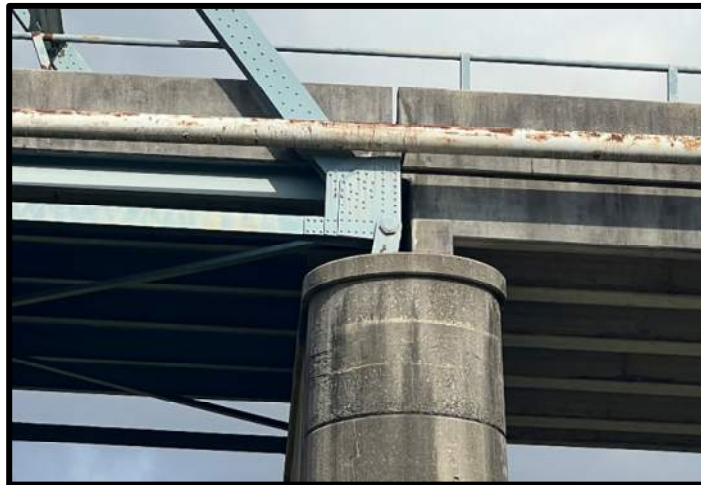
Photo 48: Truss 3, Bearing Device – Tilted East

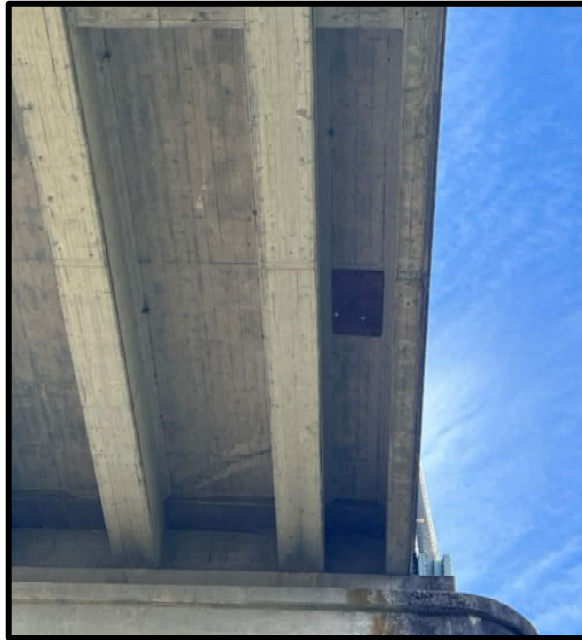
Photo 49: Span 7, Beam A & B – Patched Spall with Plywood, Beam B & C – Crack near Pier 4

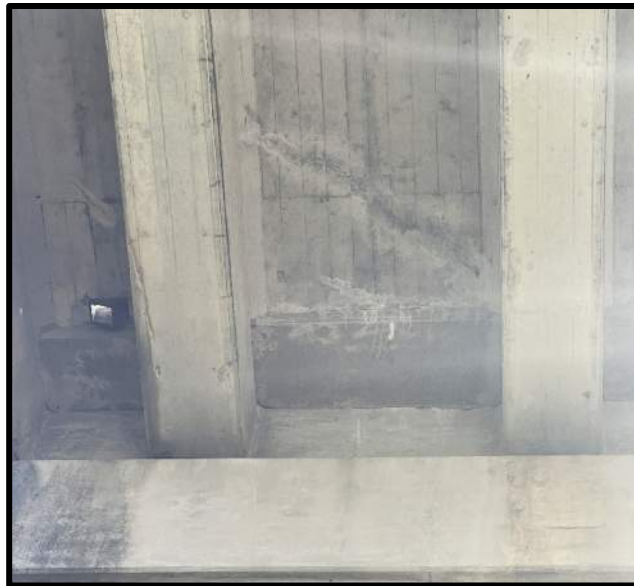
Photo 50: Span 7, Beam B & C – Crack and Efflorescence near Bent 5

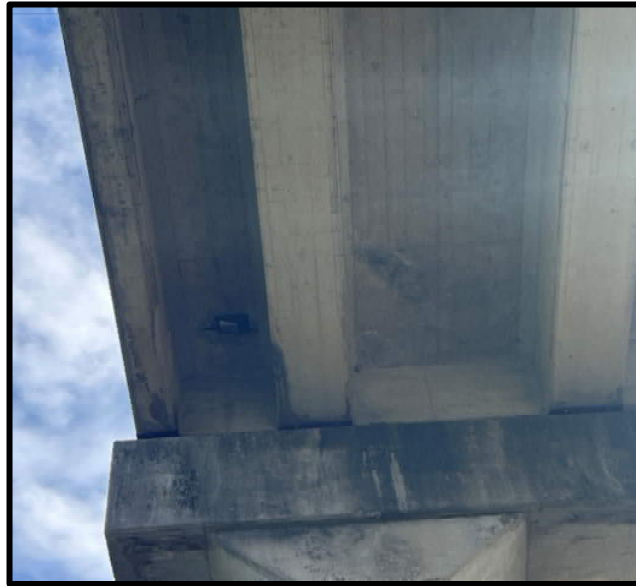
Photo 51: Span 8, Beam A & B – Spall Around Drain near Bent 6, Beam B & C – Crack near Bent 6

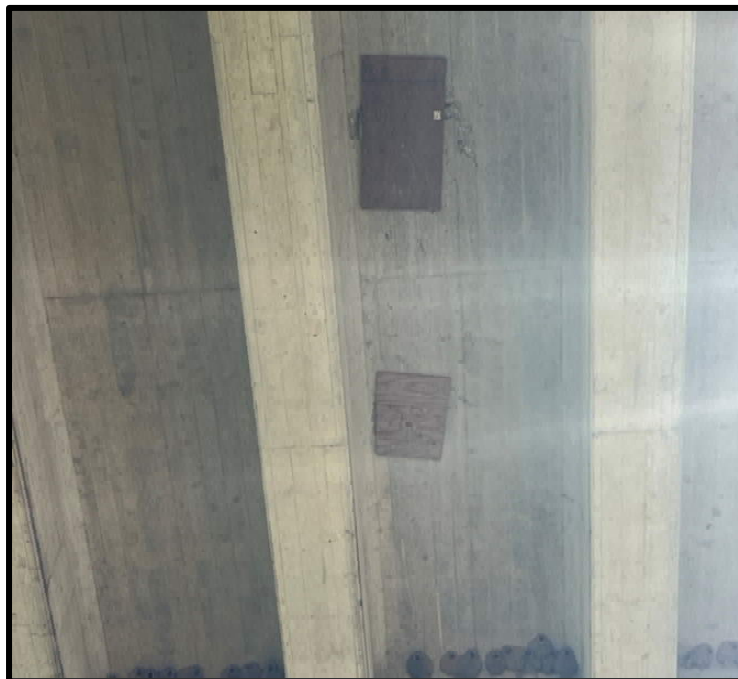
Photo 52: Span 8, Beam C & D – Patched Spalls with Plywood near Bent 5

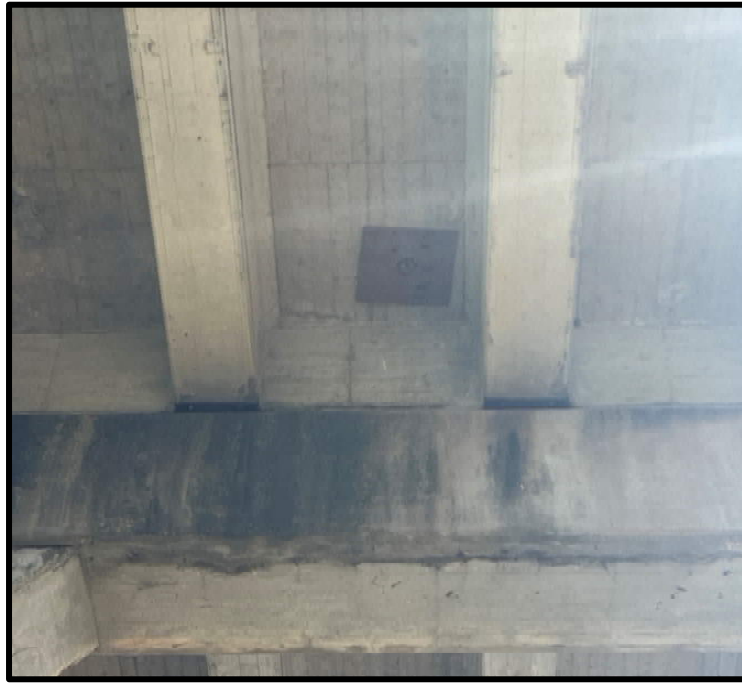
Photo 53: Span 8, Beam C & D – Patched Spall with Plywood near Bent 6
