Subject: Boyds Bridge over Holston River Evaluation Report
Knoxville, Tennessee
Gresham Smith Project No. 48881.00

At the request of The City of Knoxville and in lieu of a full bridge inspection report, the following letter serves as an executive summary of the routine bridge inspection, as defined in the USDOT FHWA Bridge Inspector's Reference Manual (BIRM) (Publication No. FHWA NHI 12-049), of the Boyds Bridge located in Knox County, Tennessee at 4078-4226 Boyds Bridge Pike, Knoxville, TN 37914. The purpose of this letter is to provide The City of Knoxville with information on the November 7th, 2024 evaluation approach, findings, results and recommendations. The evaluation was performed by Gresham Smith using staff that meet the bridge inspector qualifications outlined in The *Code of Federal Regulations*, Title 23, Part 650, Subpart C, Section 650.309. Gresham Smith staff on site for the evaluations were Griffin Bedell, EI, NHI and Russell Childs, PE, NHI.

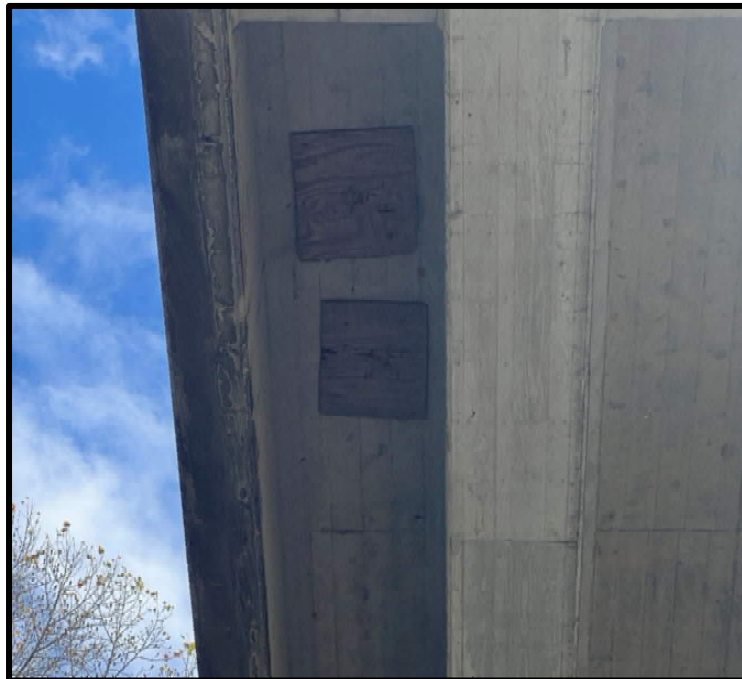
Photo 54: Span 9, Beam A & B – Patched Spalls with Plywood near Bent Midspan

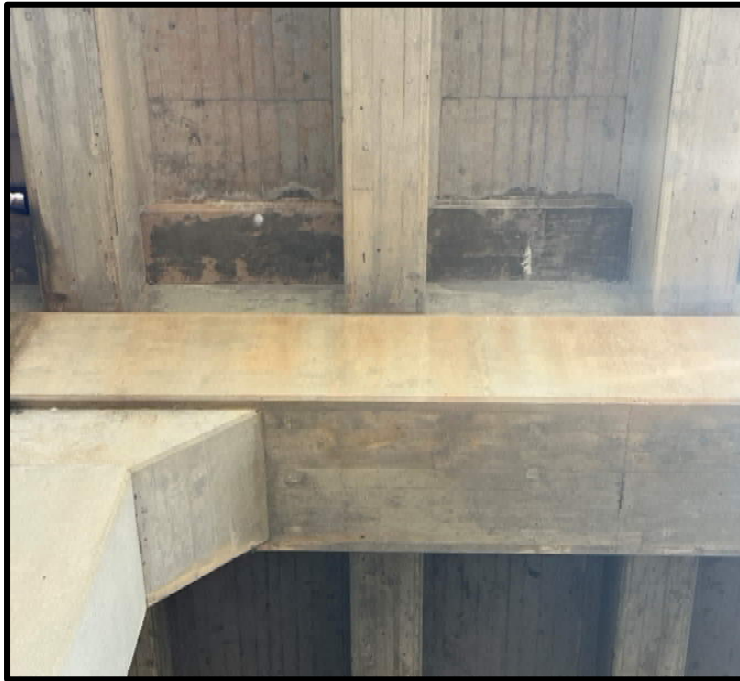
Photo 55: Span 9, Beam B & C & D – Efflorescence near Bent 7

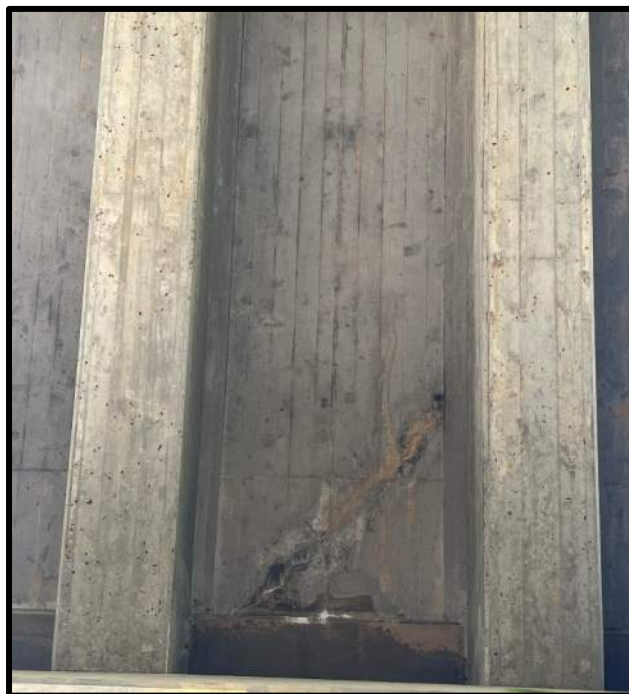
Photo 56: Span 10, Beam B & C – Crack near Bent 7

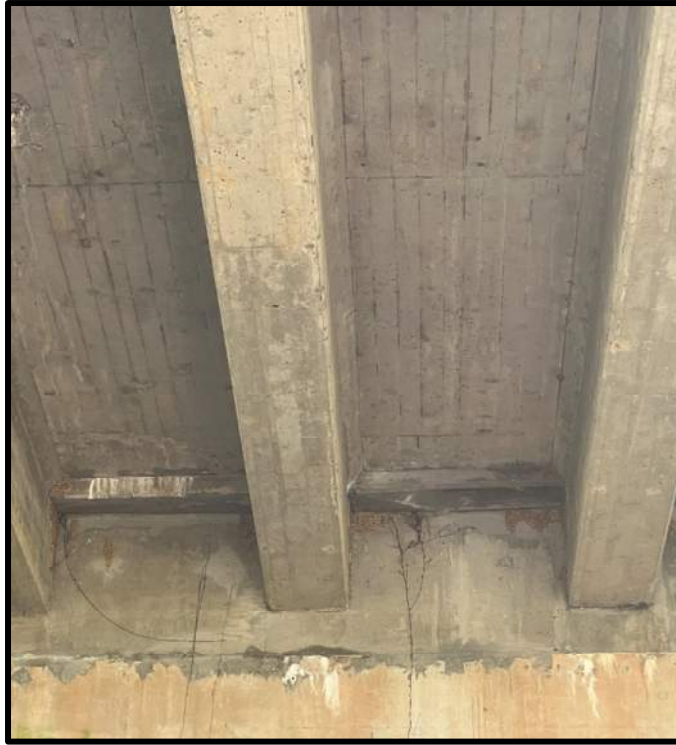
Photo 57: Span 10, Beams B & C & D & E – Efflorescence near Abut. 2
